ER0023
Errata
SmartFusion Devices

This errata sheet contains updated information about any known SmartFusion[®] device family specific issues and provides available fixes and solutions.

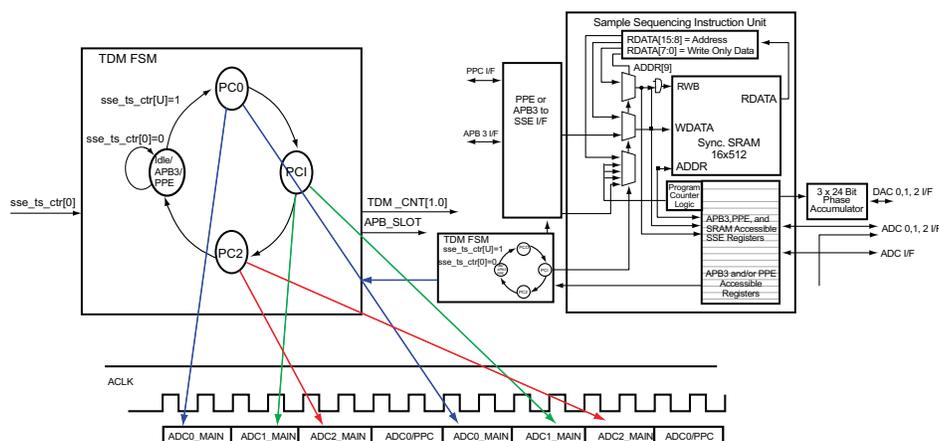
Figure 1 • SSE Micro Architecture

The TM4 and CM4 are pads that connect directly to the ADC2 (available only on the A2F500 device). Part of the ACE controller is a Time Division Multiplexing (TDM) FSM, which implements a mechanism to sequence through the different ADCs available on the SmartFusion devices. The FSM allows equal access through three separate program counters. program counter0 (PC0) is associated with ADC0. program counter1 (PC1) is associated with ADC1 and program counter2 (PC2) is associated with ADC2, as shown in the following figure.

The strobe channels on ADC2 (current, temperature, differential voltage) are instead made available through the ADC Controller tab in software on the procedures that are targeted for ADC0 or ADC1 (instead of ADC2 where they are supposed to be available). This is a software workaround. Even though the ADC2 analog signal moved under the PC0 and/or PC1 time slot, physically those analog signals are still connected to ADC2 and are sampled on the ADC2. You should be aware that there will be a contention when sampling is performed on one ADC and then simultaneous samples are performed on the other procedure using the same ADC. The likely outcome of such a scenario is that the samples are dropped. Furthermore, the ACE controller issues a warning, as shown in the following figure.

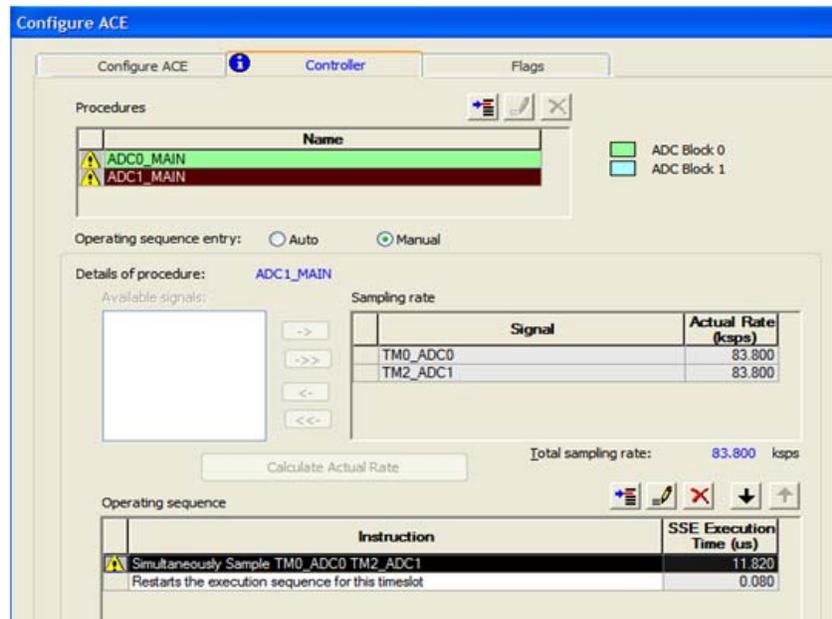
Figure 2 • Sampling Simultaneous Operations

Note: Sampling of TM0_ADC0 conflicts with simultaneous operation of procedure(s) for ADC0. See, the ACE Configuration user guide for more information.

The ACE driver Use Guide has an API that you can use to enable/disable the procedures.

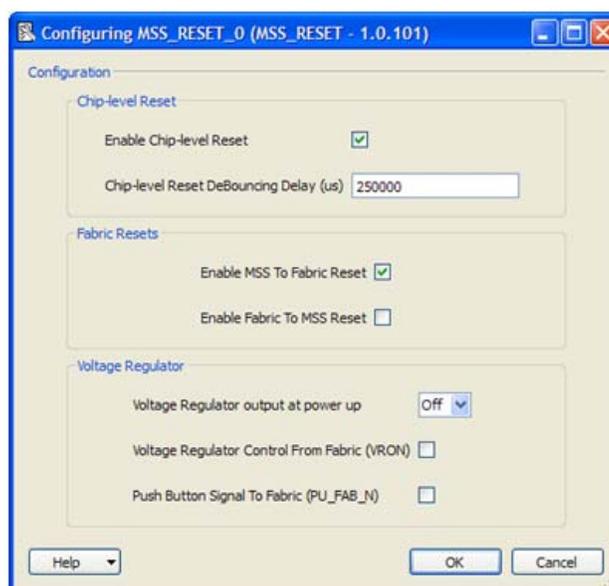
Figure 4 • Reset Management Configurator

This issue happens if the debouncing delay generated by the external reset chip does not match the chip level reset debouncing delay specified in the Reset Management configurator in the MSS, as shown in the following figure.

Ensure that the chip level reset debouncing delay specified in the Reset Management configurator in the MSS matches the external reset chip delay.

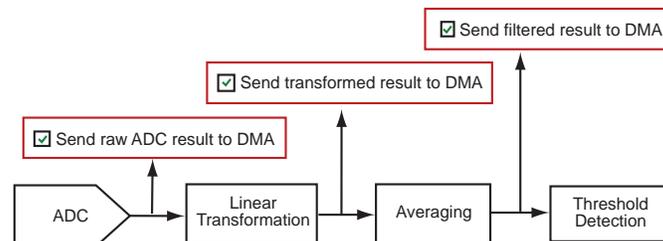
Figure 7 • ACE Data Path Available Tapping Points

In Libero SoC v10 SP1, the PPE microcode is incorrectly generated when **Send filtered value to DMA** is enabled. Prior to Libero SoC v10 SP1 the microcode was generated correctly.

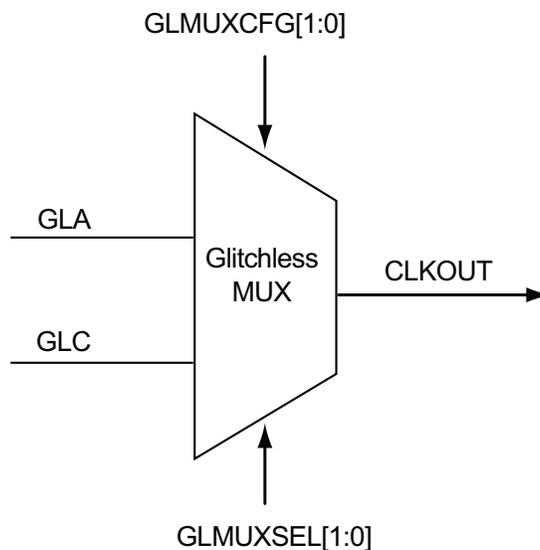
Figure 8 • Glitchless Multiplexer

The NGMUX is a 2:1 multiplexer that switches glitch-free between two different clock sources and outputs the new clock to the global network, as shown in the following figure. Before switching the NGMUX, the clock source being switched to must be stable to avoid clock glitches propagation through the NGMUX. If not, the NGMUX can propagate those glitches.

The signal assigned to the GCAx pins (Example: GCA0/IO36NDB1V0, GCA1/IO36PDB1V0, and others) as a CLKBUF or CLKBUF_LVPECL or CLKBUF_LVDS goes through the glitchless mux. For the glitchless mux to operate correctly, the signal must be a free-running clock signal. See the “**Glitchless MUX**” section in the *SmartFusion Microcontroller Subsystem User Guide* for more information. Verify that the signal driving this instance is a continuous clock signal.
