SmartFusion®2 Device Errata

Introduction

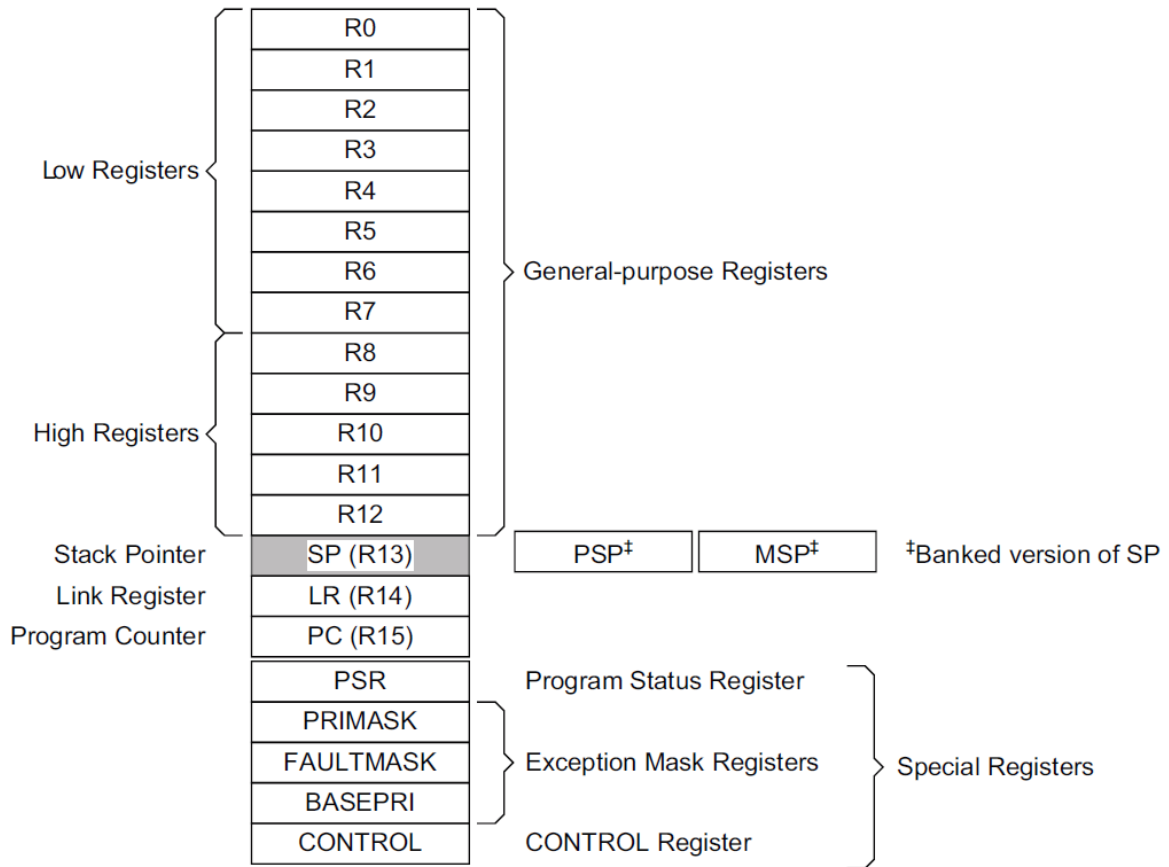
Figure 1-1. Cortex-M3 Core Register Set

Cortex-M3 internal general-purpose registers (for example R6) gets corrupted when two nested D-Bus (must be a non-64-bit-aligned access) and I-Bus cache miss cycles occur in cache controller fetching from eNVM followed immediately by a D-Bus read without cache miss.

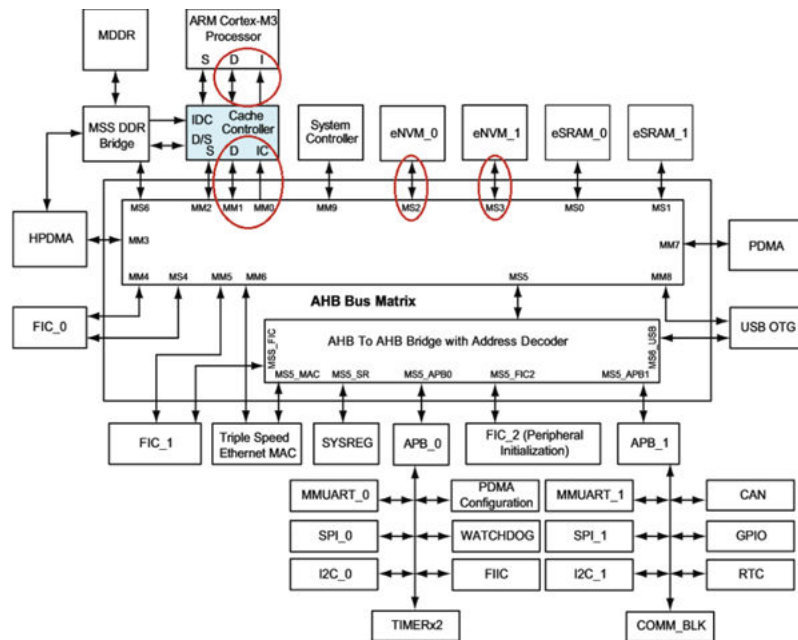
Figure 1-2. Cache Controller Interfaces and Paths Affected by CN (Red Circles)

SmartFusion2 system implements a cache controller in between Cortex-M3 and the memory subsystems (eNVM, eSRAM, Fabric sRAM, and DDR). An AHB matrix is used to arbitrate between eNVM, eSRAM, and Fabric sRAM access while a separate dedicated bus interfaces with DDR.

When the cache controller is enabled and mapped to eNVM, the following sequence of operations causes I-Bus and D-Bus accesses to be queued internally, leading to a state analogous to an I-Bus and D-Bus concurrent access.

1. A D-Bus miss has occurred to a non-aligned 64-bit address causing the cache controller to fetch the data from eNVM. This misaligned transaction extends the memory bus cycle.
2. While the cache logic is completing the cache fill operation after fetching from eNVM, an I-Bus miss occurs. The I-Bus operation is put on hold while waiting for cache filling operation to complete.
3. While I-Bus operation is in a wait state, a D-Bus read without a cache miss occurs. For this event to occur the D-Bus read must be within three cycles (the number of Cortex-M3 pipeline stages) to the I-Bus read/miss, a situation that mimics a simultaneous I-Bus and D-Bus read access.

A D-Bus read takes the precedence over an I-Bus but the data loaded into the Cortex-M3 internal register (for example, R6) is erroneously the I-Bus data which causes the corruption and consequently the application fails in an unpredictable manner.

1. Add one the following compiling options depending on the toolchain used. This option prevents a D-Bus read to happen after I-Bus read. The following is a list of most common compilers used.

- Keil, `--no_integer_literal_pools` or similar options
- IAR, `--no_literal_pool`
- GCC-ARM, `-mpure-code`

2. Recompile the code and update the executable code on the boot medium.
