**ER0195**  
**Errata**  
**SmartFusion2 M2S050 (T,TS)**

This errata sheet contains the specific device errata and the affected SmartFusion2<sup>®</sup> M2S050 (T,TS) revisions of commercial and industrial devices.

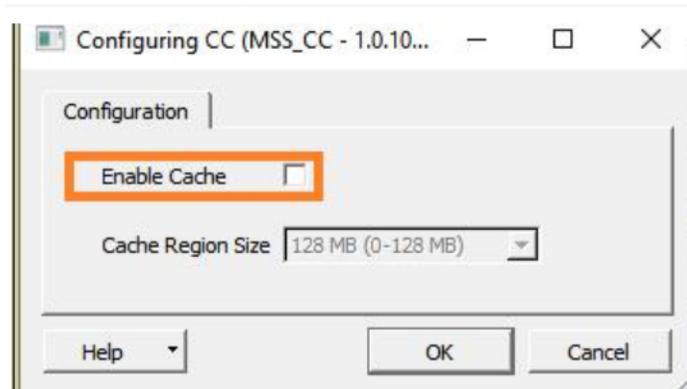
Figure 1 • Disabling Cache in Cache Configurator

A concurrent access of the Cortex-M3 I-Bus and D-Bus may result in an invalid value returned to the internal registers from the cache when both accesses are sourced by the cache.

- **Workaround 1:** IAR toolchain users can fix this problem by preventing the Cortex-M3 processor from issuing concurrent I and D buses access through the cache by locating the constants and data variables outside the memory regions accessed by the cache to prevent conflicts in the linker scripts. The compiler also requires adding the `-no_literal_pool` option to prevent the compiler/assembler from locating variables close to instructions known as literal pools. For more information, refer to section 4.2.3.3.1 from *UG0331: SmartFusion2 Microcontroller Subsystem User Guide*.
- **Workaround 2:** Cache can be turned off by disabling the **Enable Cache** check box in the **Cache Configurator** of the SmartFusion2 MSS Subsystem, as follows.
