## CN20006: RTG4 Family Important Changes

May 6, 2020

This document describes the following three changes to the RTG4 product family.

## CN20006.1: “Configure I/O States During JTAG Programming” Libero Tool Causes Loss of Programming Configurations for RTG4 FPGAs

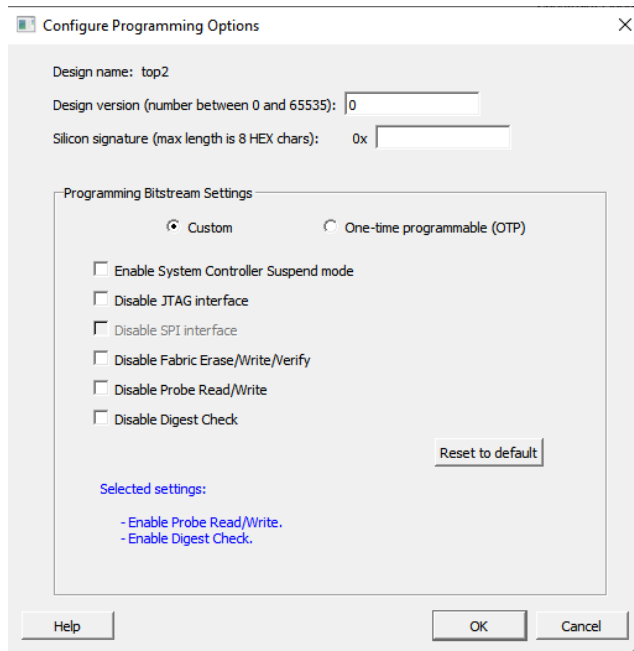
**Figure 1 • RTG4 Programming Options GUI**

In Libero SoC v12.0 to v12.3, using the configuration tool to “Configure I/O States During JTAG Programming” can cause a loss of user programming settings selected via “Configure Programming Options”, “Configure Action/Procedure” for the “Run Programming Action” step, and “Generate Bitstream” options.

When operating an RTG4 device, if System Controller Suspend mode is selected, this issue could permanently prevent the device from exiting System Controller Suspend mode, and permanently lose the capability of reprogramming the device. We recommend upgrading to Libero SoC v12.4.

- If System Controller Suspend Mode (SCSM) is enabled (which automatically disables the JTAG interface), the bitstream generated after configuring I/O states during programming can prevent all further JTAG access, and thus permanently prevent further device programming with Scan Chain failure and "TDO stuck at {0,1}" msg.

- If Fabric Erase/Write/Verify is disabled, the bitstream generated after configuring I/O states during programming can permanently prevent further JTAG programming with the “Operation has been disabled by programming bitstream settings” message.

- For RTG4, this issue only occurs if running “Configure I/O States During JTAG Programming” in Graphical User Interface (GUI) mode.
- There is no issue if the “Configure I/O States During JTAG Programming” GUI is not used, no issues in Tcl scripted mode.

Do not program any further RTG4 devices with programming files (Libero SoC v12.0 to v12.3) using I/O states during programming GUI combined with the programming options listed above. Upgrade to Libero SoC v12.4, observe that all "Generate" and "Export" programming steps in the design flow will be invalidated, then re-run I/O States GUI and re-configure Programming/Bitstream options prior to Generating and Exporting new bitstreams.
