Date: February 25, 2009

PCN Number: 0902

Subject: Minor Fix to Axcelerator® and RTAX-S Programming (*.afm) File Generation to Address Programming Failure for Specific Conditions Only

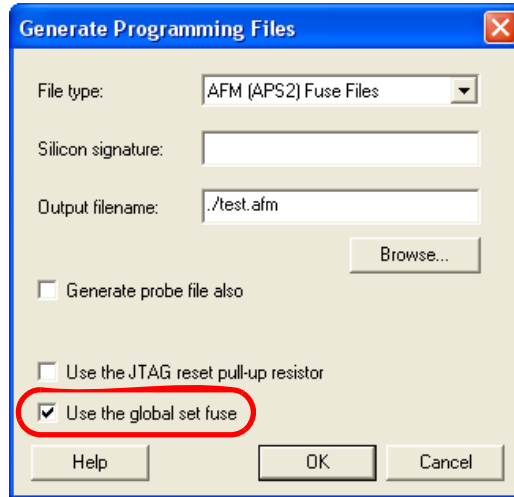
Actel has successfully completed the investigation and determined the root cause of programming yield loss. Analysis performed on the programming failures revealed that the special antifuse referred to as "GBSETFUS" fails programming. This antifuse is included in the AFM file for programming if and only if the **Use the global set fuse** option is selected in the Generate Programming File window in the Designer suite, as shown below. This specific antifuse (GBSETFUS) can be invoked during generation of programming file (*.afm) to set the internal registers (R-cells) to a value of "1" after power up. An error in the Designer software resulted in an incorrect condition being set for this antifuse in the AFM file when it was addressed by the Silicon Sculptor programming software, thereby resulting in this programming yield loss.

A Libero® Integrated Design Environment (IDE) software fix (release number 8.5SP1) has been implemented to ensure correct addressing of this particular antifuse, thereby eliminating these programming failures. This software fix requires regeneration of the programming file (*.afm). The modified software can be found from: <http://www.actel.com/download/software/libero/libero85rlsp1.aspx>

1. If the **Use the global set fuse** is not selected (unchecked in Designer), there is no issue and no action is required.
2. If you are currently using the **Use the global set fuse** option and have not experienced any programming yield loss, the successfully programmed devices are reliable. Actel recommends regenerating the programming file (*.afm) if additional devices need to be programmed. Customers should use the Libero IDE service pack referenced above.
3. If **Use the global set fuse** option is selected and you have experienced any programming failures, the devices that failed to program should be returned to Actel. Please contact Actel's technical support team to initiate an RMA. To prevent additional programming yield loss, the programming file (*.afm) must be regenerated using the Designer software capture referenced below.
