RT54SX72SU Heavy Ion Beam Test Report

August 6, 2004

J.J. Wang

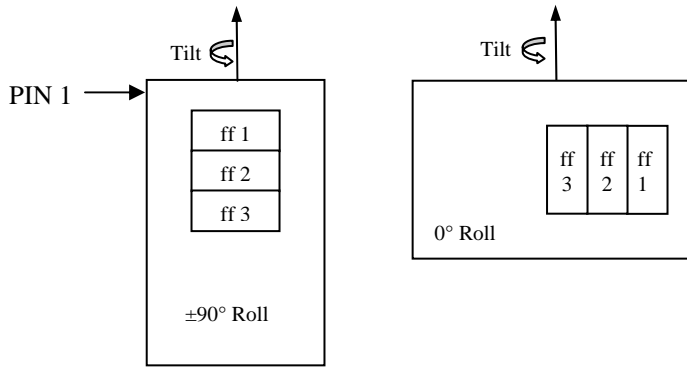
3. Figure 2 shows the importance of the board orientation; it also shows the relative orientation of the board and the hard-wired TMR flip-flop, which has three sub-flip-flops, ff1, ff2 and ff3. Only when two or more of the sub-flip-flops suffer upsets simultaneously due to an ion strike, the TMR flip-flop can have an upset. Thus the orientation of 0°-roll with a tilt gives the TMR flip-flop more susceptible to SEU than does the orientation of $\pm 90^\circ$ -roll with the same tilt. However, the data in Table 2 shows that the SEU-errors are relatively independent of the roll angles. This insensitivity to the board orientation can be explained by the wide separation of the sub-flip-flops. Three dimensional mixed mode simulation demonstrated that even at $\pm 90^\circ$ -roll and 60°-tilt orientation, a single heavy ion with LET of 100 MeV•cm²/mg cannot upset the TMR flip-flop

Figure 2 Relative orientations of the hard-wired TMR flip-flop and the DUT board.

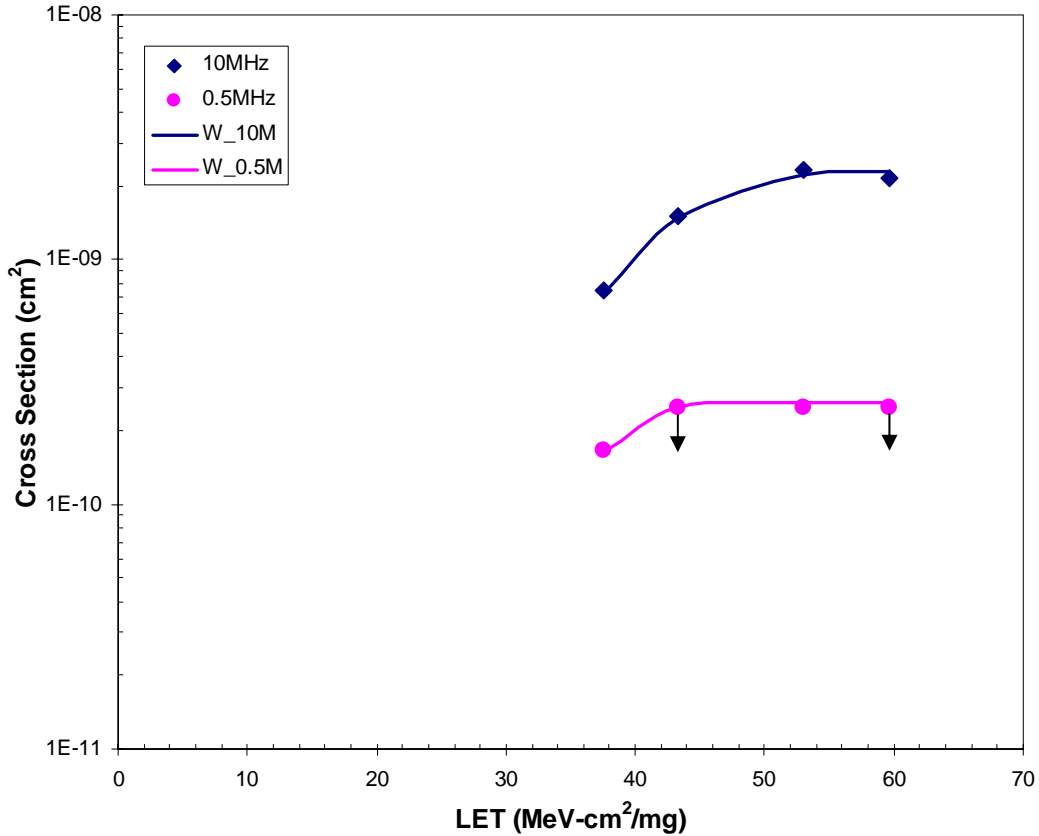
Figure 3 shows the cross-section per flip-flop with respect to LET. In this Figure, the data are derived from the DOS and DOC data in Table 2 that use the checkerboard pattern and the worst-case bias scenario, i.e. $V_{CCI}/V_{CCA} = 4.5/2.25$ V. As shown by the legend, the points are experimental data and curved lines are Weibull fits; each data point represents the average of the three DUTs. Clearly, the cross-section, or SEU-error, is strongly dependent on the clock frequency. SEU-errors for 10 MHz clock is about an order of magnitude higher than SEU-errors for 0.5 MHz. In fact, 0.5MHz data are practically in the noise level since a single error in each run can be just a noise due to accelerator operation. SpaceRad 4.5 simulator performs the SEU prediction by applying Weibull parameters to GEO solar-minimum environment with 100-mil Al shielding; the SEU rate is 3.93×10^{-12} upsets per bit-day for 10 MHz, and 2.2×10^{-14} upsets per bit-day for 0.5 MHz.

Figure 3 Cross section per register cell for 0.5MHz and 10MHz clock frequency. The points are average experimental data of three DUTs, and the curved lines are Weibull fits.
