HALT Evaluation of SJ BIST Technology for Electronic Prognostics

Abstract—This paper presents the design, test, and results of a highly accelerated life test (HALT) evaluation of a soft-core called Solder Joint Built-in Self-Test™ (SJ BIST™), a method for detecting faults caused by solder-joint fractures in monitored input/output (I/O) pins of field programmable gate array (FPGA) devices, especially those in ball grid array (BGA) type of packages. Modern electronics utilize large FPGAs packages attached to electronic boards by means of solder joints, such as solder balls, between the package and the board. Thermo-mechanical stresses – primarily heat and vibration – cause fatigue damage and eventual fracture failure of one or more balls, which causes intermittent operational faults leading to catastrophic failures in critical systems. Such intermittent faults are difficult to reproduce on a test bench and many field returns of electronic modules with intermittently failing solder balls are diagnosed with code "no trouble found/could not reproduce." The SJ BIST soft-core offers a solution because it detects faults in monitored pins caused by fractured solder joints of programmed FPG

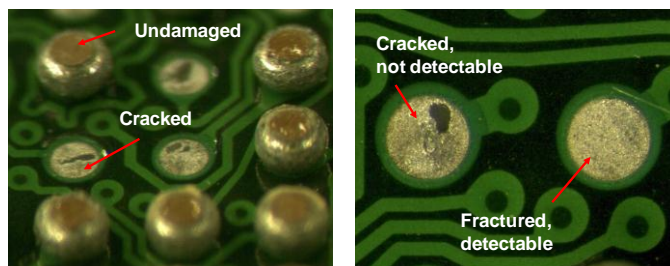
Figure 1. Damaged and undamaged solder balls.

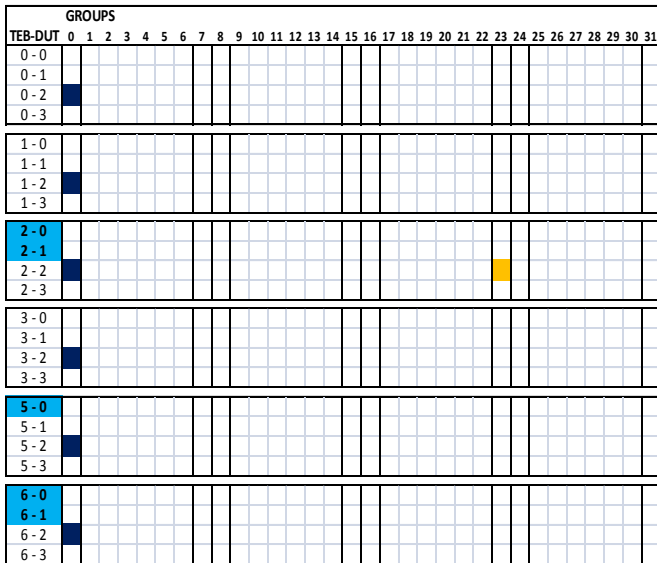
Figure 10. HALT status for cycle 4.

Five of the 24 FPGAs were found to be nonresponsive prior to starting the HALT: Board 2, FPGAs 0 and 1; board 5, FPGA 0; and board 6, FPGAs 0 and 1. Because of time and budget constraints, we elected to not fabricate replacement boards. The logged data for HALT cycle 4 (HC4) confirmed the null responses from those FPGAs.

In addition to reporting a null response from FPGA 0 and 1, the data log (see Fig. 9) for board 2 showed pin group 0 of FPGA 2 had a hard error on both pins. This same error occurred on FPGA 2 on all boards. The data log also indicated that both pins in group 23 of that FPGA were open: subsequent cycles indicated that group experienced intermittent faults. The “POWER ON” record indicates this is the first log after the board was powered on.

Fig. 10 is a graphical view of the HALT status: ■ = no response from the indicated FPGA, ■ = solid error(s) in the indicated pin group, ■ = intermittent faults in the indicated pin group, ■ = no data written, and ■ = over 100 intermittent faults in the indicated pin group. The eight outlined groups are those nearest a corner of a DUT.

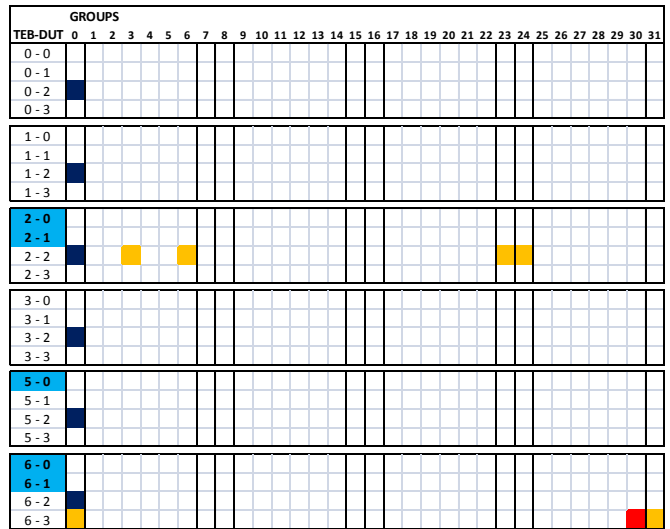
Figure 11. HALT status for cycle 23.

Continuous HALT cycling began 16 November and on 20 November the logged data for cycles 5 through 23 were sent to Tucson for analysis to verify the firmware and software to collect and log data were working correctly. Fig. 11 shows intermittent faults occurring in six additional pin groups.

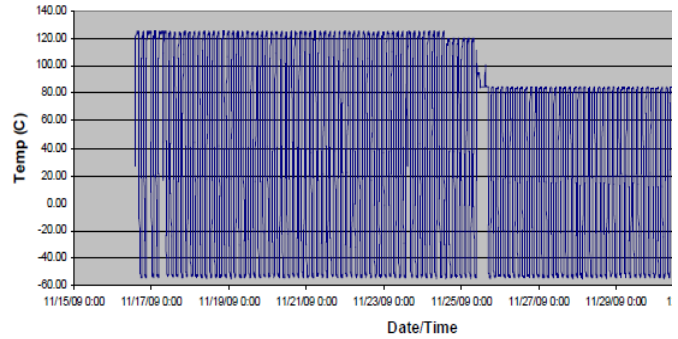
Figure 12. Partial profile of the chamber temperature.

On 25 November, it was noticed the 5A 5VDC power supply was going into current-limiting mode. We decided to reduce the oven temperature to 85°C (see Fig. 12) until we could replace the original with a larger power supply. When we examined the logged data records, and we determined the previous damage to boards 2 and 6 had increased as shown in Table III, Table IV, and Fig. 13:

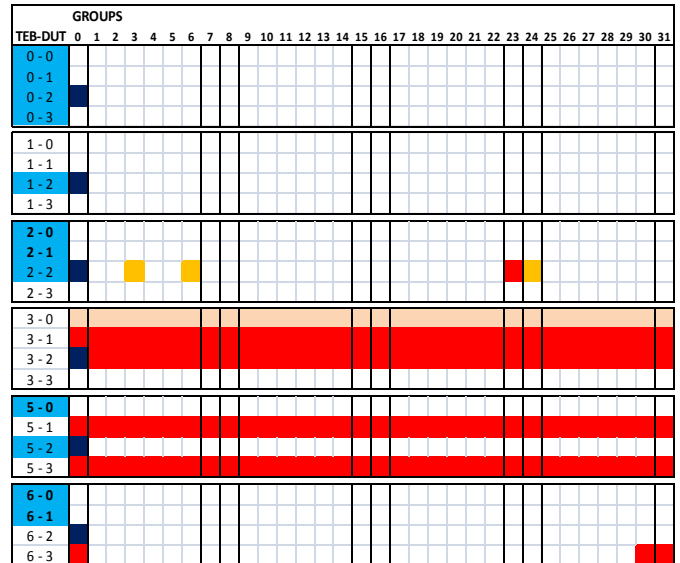
Figure 14. HALT status at end of cycle 204 (13 January 2010).

The logged data records ending 13 January were sent to Tucson for examination: nine new error and fault conditions were noted as shown in Table V and Fig 14. The team in Tucson asked the team in Johnson City to examine the cables: the RS-232 cables exhibited high-heat damage to include brittle and broken insulation, and interior material liquefied and oozing (see Fig. 15). The HALT was again suspended on 29 January pending replacement of the RS-232 cables. Board 0 was returned to Tucson for physical examination: there was no visible sign of damage.

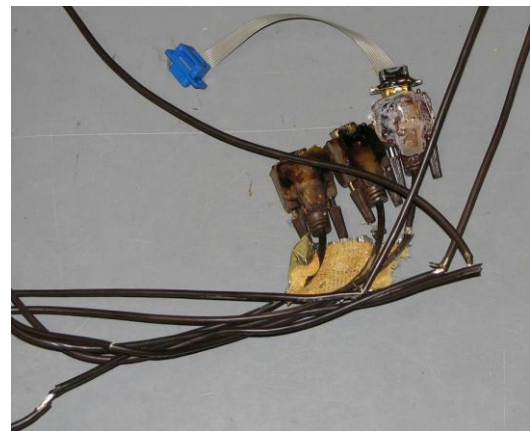
Figure 15. Heat damaged RS-232 cables.

The HALT was resumed 9 February after the RS-232 cables were replaced (cycle 258) with logging resumed that day starting with cycle number 287. Examination of the logged records indicated that three boards were once again responding: board 2, FPGA 3 (no faults); board 3, FPGAs 1, 2 and 3 (no faults); and board 5, FPGAs 1, 2, and 3 (high fault counts on all three FPGAs)⁴. 12 operational FPGAs out of the 20 on the remaining five boards (board 0 had been returned for inspection).

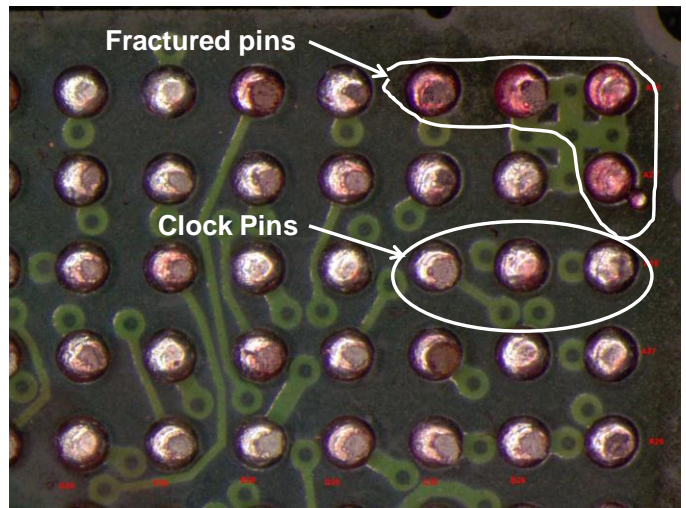
Figure 18. Dye and pry of board 2, FPGA 0.

For the dye and pry examination (37 images), we selected board 2, FPGA 0, which was reported as null response from the very start of the HALT. Fig. 18 shows the one of the corners (A30) and clearly shows a failed pin next to the four corner (ground) pins, and three of the four ground pins fractured. At all four corners, there was at least one ball next to the corner that was fractured.

Looking at the middle clock pin shown in Fig. 18, the appearance of the ball indicates it was not securely attached to the board land – there is a lack of solder damage from the pry. This might have caused a loss of the clock, which might explain the non-responsiveness of that FPGA.

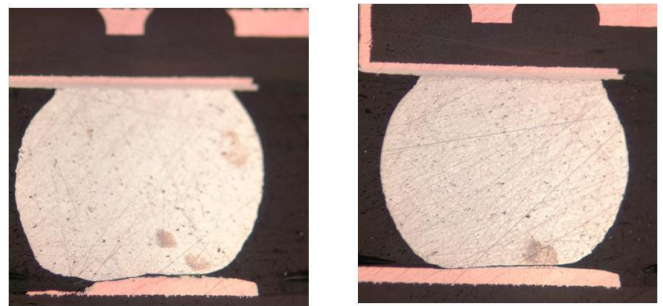
Figure 19. Pins C1 (left) and G1 (right), board 6, FPGA 3.

We cross sectioned 48 pins and examined 103 images. We concluded the following: pins that SJ BIST reported as having faults were fractured (no false alarms), an example of two pins C1 from group 31, board 6, FPGA 3 and G1 from group 30, board 6, FPGA 3 are shown in Fig. 19. Both balls are fractured, and referring to Fig. 17, SJ BIST detected high number of faults. With one possible exception (see Fig. 21), no fractures were found in pins SJ BIST reported as healthy. Fig. 20 shows two pins monitored by SJ BIST and for which no faults were reported: those pins were not fractured.

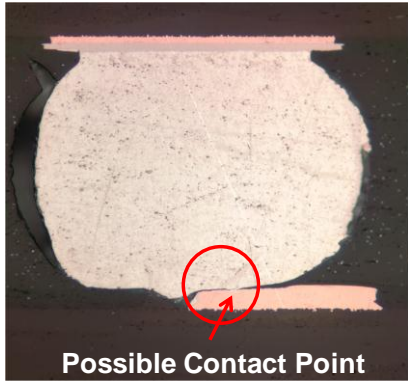
In addition to the possible contact point shown in Fig. 21, a fault might not occur for any number of other reasons: (1) The cross sectioning might have hidden a partial contact point (see

Figure 21. Fault not detected: board 6, FPGA 3, pin A24.

This apparent fracturing with no detectable occurrence of faults is an example of the intermittent nature of solder-joint caused faults. Another example is cycle 54: SJ BIST reported the occurrence of only two faults each for board 6, FPGA 3, group 31, pins C1 (which Fig. 19 shows is clearly fractured) and C2. There were a total of 270 billion – yes, billion – writes of a ‘1’ bit to each of those two pins in that 3-hour HALT

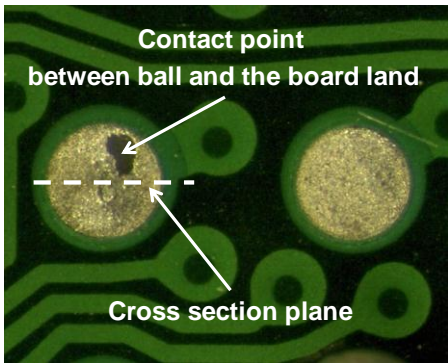
Figure 22. Cross sectioning can hide a partial contact point.
