**ER0196**  
**Errata**  
**SmartFusion2 Device v1.5**

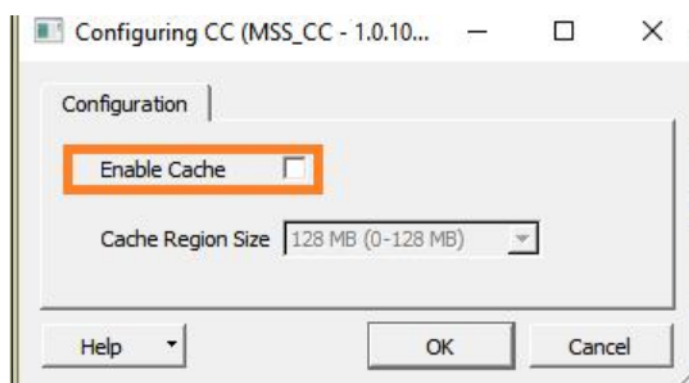
**Figure 1 • Disabling Cache in Cache Configurator**

A concurrent access of the Cortex<sup>®</sup>-M3 I-Bus and D-Bus may result in an invalid value returned to the internal registers from the cache; when both accesses are sourced by the cache.

- **Workaround 1:** IAR toolchain users can fix this problem by preventing the Cortex-M3 processor from issuing concurrent I and D buses access through the cache by locating the constants and data variables outside the memory regions accessed by the cache to prevent conflicts in the linker scripts. The compiler also requires adding the `-no_literal_pool` option to prevent the compiler/assembler from locating variables close to instructions known as literal pools. For more information, refer to section 4.2.3.3.1 from *UG0331: SmartFusion2 Microcontroller Subsystem User Guide*.
- **Workaround 2:** Cache can be turned off by disabling the **Enable Cache** check box in the **Cache Configurator** of the SmartFusion2 MSS Subsystem, as follows.
