Microsemi Corporation
September 29, 2016

Customer Notification No: 098-50620-89 Rev A
(Field Service Bulletin)

Customer Advisory Notice (CAN)

Subject: Handling of leap second insertion on December 31st, 2016 within various products.

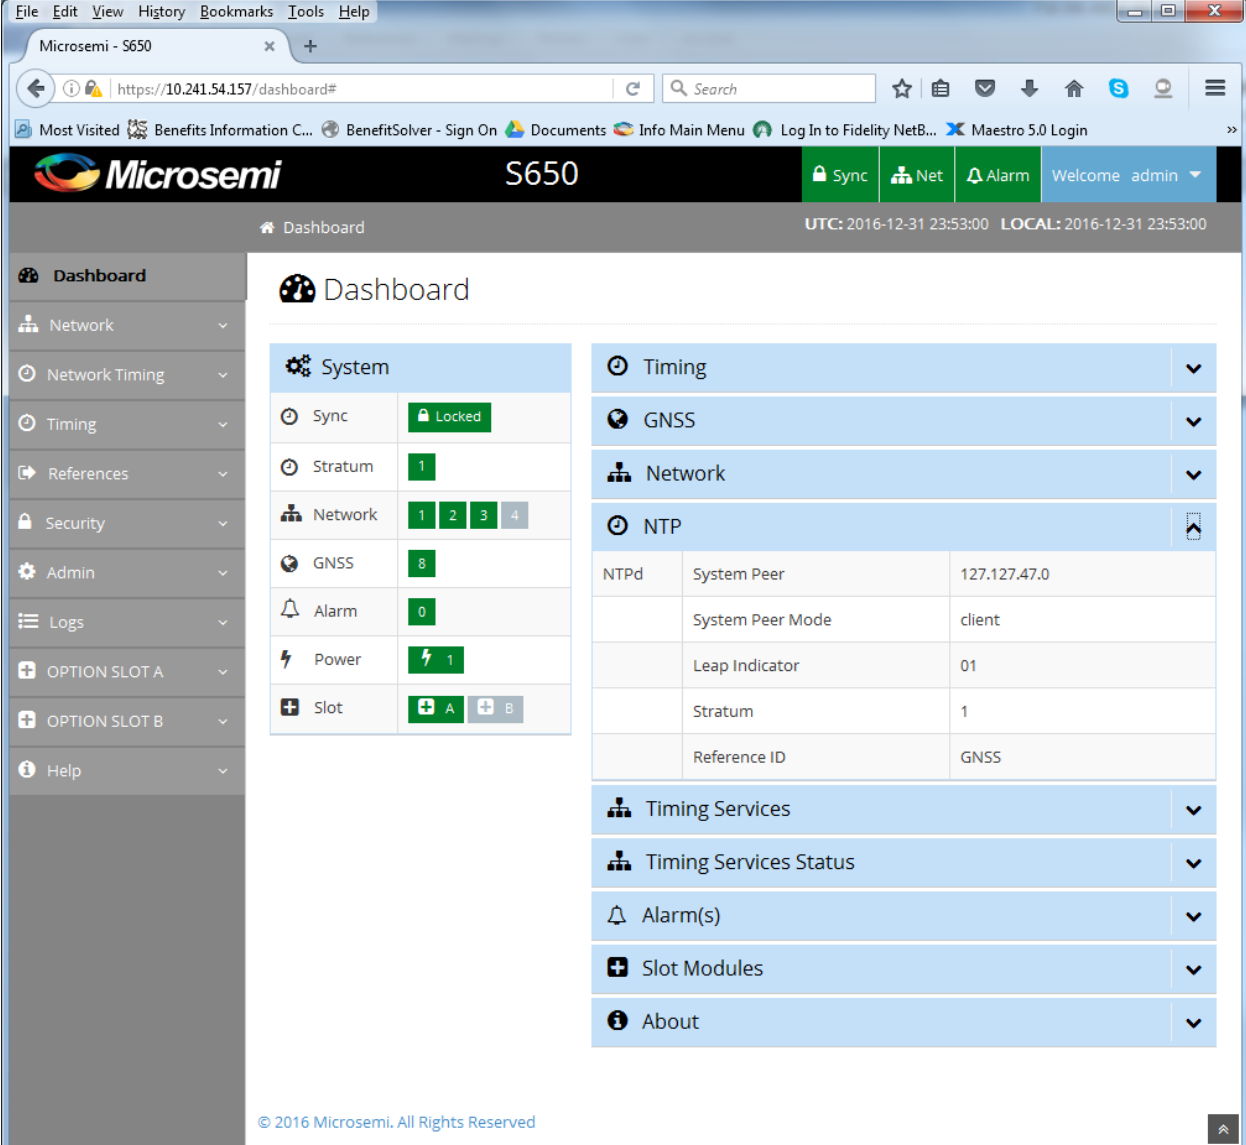
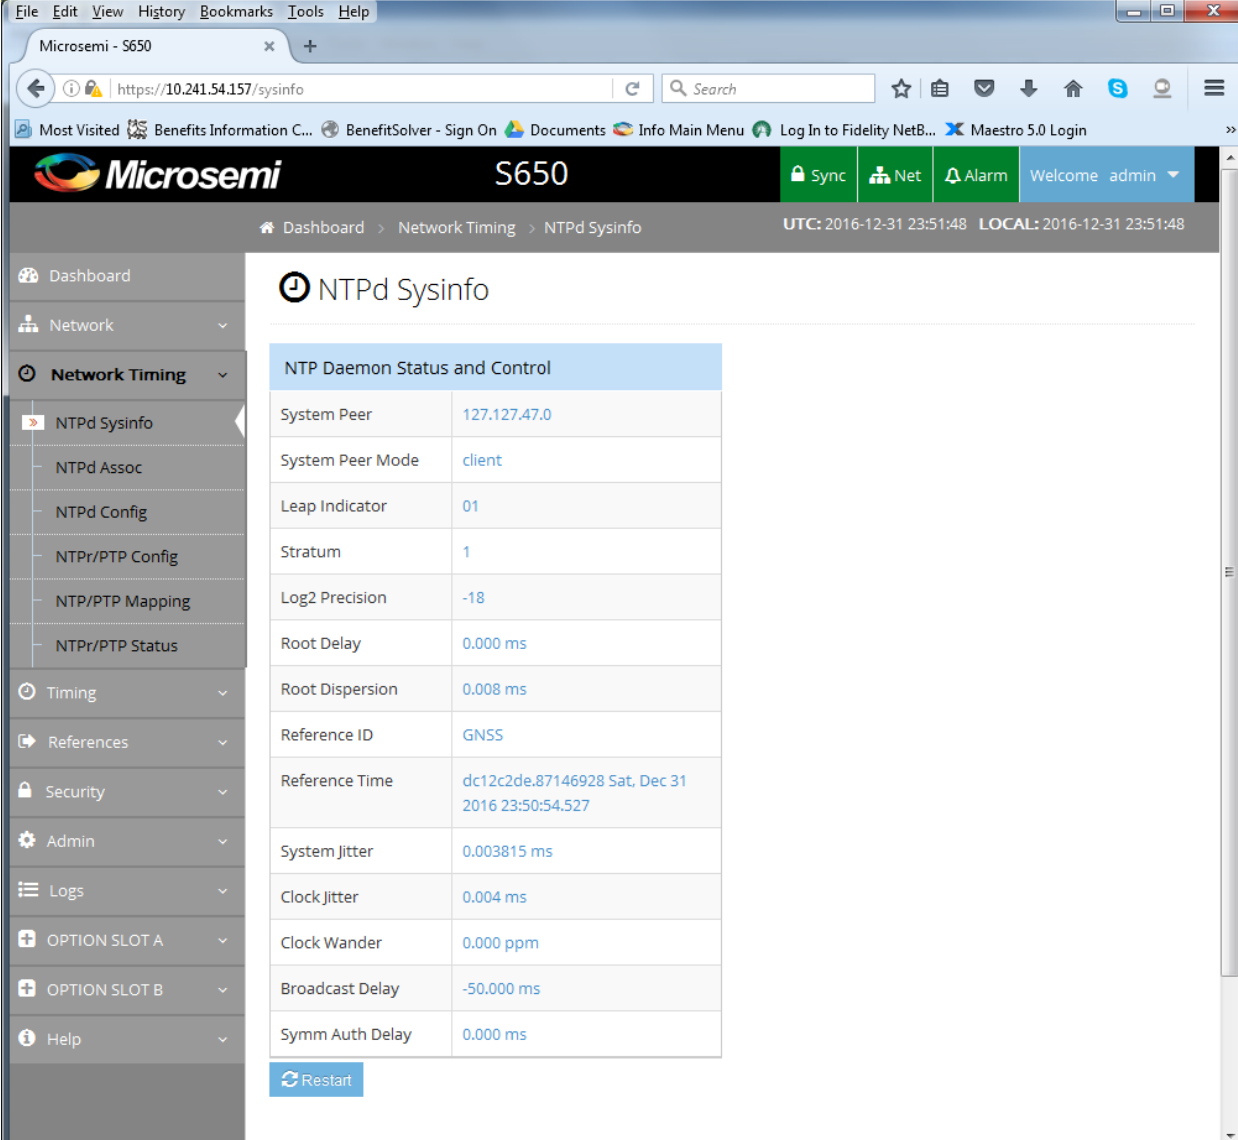
S600, S650: The pending leap indicator flag is available on the Dashboard NTP web page of the product and also available on the Network Timing NTPd Sysinfo web page.

To ensure that the pending leap second is handled properly by the products, do ensure that they are currently operating with the latest firmware releases. Details about the latest firmware release for each of the product is available on Microsemi's online support website.
