Real-Time BIST Detector for BGA Faults in Field Programmable Gate Arrays (FPGAs)

James P. Hofmeister, Justin Judkins, Ph.D., Edgar Ortiz, Douglas Goodman,
Ridgetop Group, Inc.
3580 West Ina Road,
Tucson, Arizona 85741 USA
Hoffy@ridgetop-group.com, Justin@ridgetop-group.com

Abstract - In this paper we introduce a solder-joint built-in-self-test (SJ BIST) for detecting high-resistance and intermittent faults in operational, fully programmed field programmable gate arrays (FPGAs). The approach is simple to implement, offers a method to detect high-resistance faults that result from damaged solder joints, and uses a maximum of one small capacitor externally connected to each selected test pin or each group of two test pins.

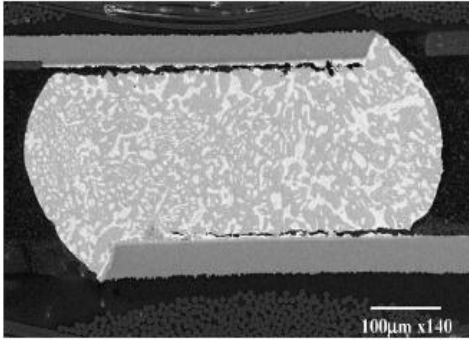
Figure 1: Crack Propagation at the Top and Bottom of a Solder Joint, 15mm BGA [2]

Solder-joint damage under thermo-mechanical and shock stresses is cumulative; damage manifests in the form of plastic work and cracks, which propagate until the eventual fracture of solder joints [1-4], resulting in FPGA operational failures. An illustration of a fractured solder joint (or bump) under thermo-mechanical stresses is shown in Figure 1. Thermo-mechanical stresses may result from differential expansion under environmental and operational temperature exposure due to coefficient of thermal expansion (CTE) mismatches. Shock loads may be imposed during shipping and normal operation in harsh environments. Even though one or more solder balls (bumps) are cracked, a solder-joint network belonging to a damaged bump might not immediately experience a catastrophic failure. One reason for this is that other solder balls of the BGA package remain intact and tend to keep the package pressed toward the board to maintain electrical contact between the surfaces of cracks [4-6].

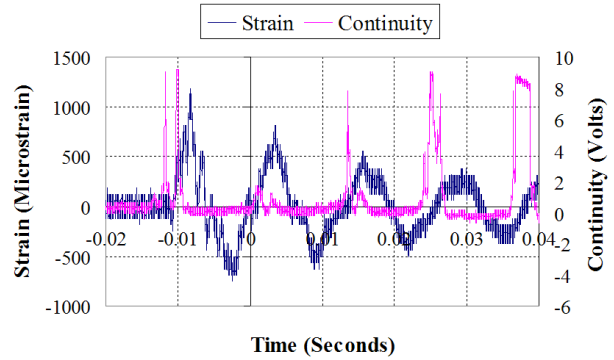
Figure 2: Shock-actuated Failure: Transient Strain and Resistance

These intermittent faults increase in frequency as evidenced by a practice of logging BGA package failures only after multiple events of high resistance: an initial event followed by some number (for example, 2 to 10) of additional events within a specified period of time, such as ten percent of the number of cycles of the initial event [8-10]. Even then, an intermittent fault of high resistance in a solder-joint network might not result in an operational fault. For example, the high-resistance fault might happen in a ground or power connection, or it might happen during a period when the network is not being written, or it might be too short in duration to cause a signal error. Figure 2 shows a shock-actuated intermittent OPEN (high resistance) of a package interconnect.

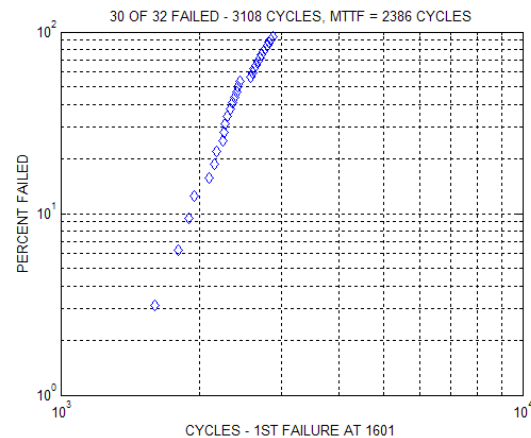
Figure 3: Representation of XILINX FPGA HALT Test Results [9]

Figure 3 represents HALT test results performed on XILINX FG1156 Daisy Chain packages in which 30 out of 32 tested packages failed in a test period consisting of 3108 cycles. Each temperature cycle of the HALT was a transition from -55°C to 125°C in 30 minutes with 3-minute ramps and 12-minute dwells. What is not immediately apparent is that each of the logged FPGA failures (diamond symbols) represents at least 30 events of high resistance: a FAIL was defined as being at least two OPENS (net resistance of 500Ω or higher) within one temperature cycle, log 15 FAILURES [9]. A single fault in a temperature cycle was not counted as a FAIL event.

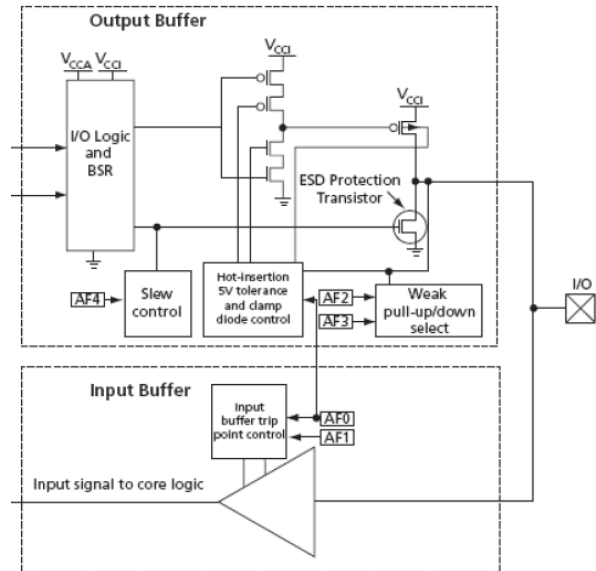
Figure 4: Example of an FPGA I/O Buffer [16]

Prior to this innovation, there were no known methods for detecting faults in operational, fully programmed FPGAs. Furthermore, FPGAs are not amenable to the measurement techniques typically used in manufacturing reliability tests such as Highly Accelerated Life Tests [4]. This is because those measurement techniques require devices to be powered-off and because FPGA I/O ports are digital, rather than analog, circuits, an example of which is shown in Figure 4.

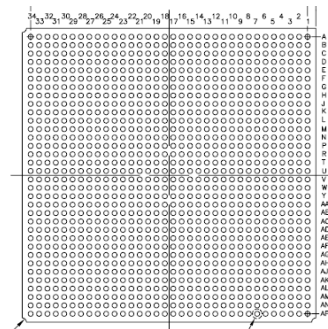
Figure 5: Bottom View of a XILINX FG1156 – Package Size is 35 x 35 mm with a 34 x 34 Array of Solder Balls of Nominal Diameter of 0.6mm and Pitch of 1.0mm [17]

Modern BGA FPGAs, such as the fine-pitch XILINX FG1156, have more than a thousand I/O ports and very small pitch and ball sizes. For example, the FG1156 has a 34 x 34 array of nominal 0.60mm solder balls with a pitch of 1.0mm (see Figure 5). This tends to make physical inspection techniques impractical and not useful.

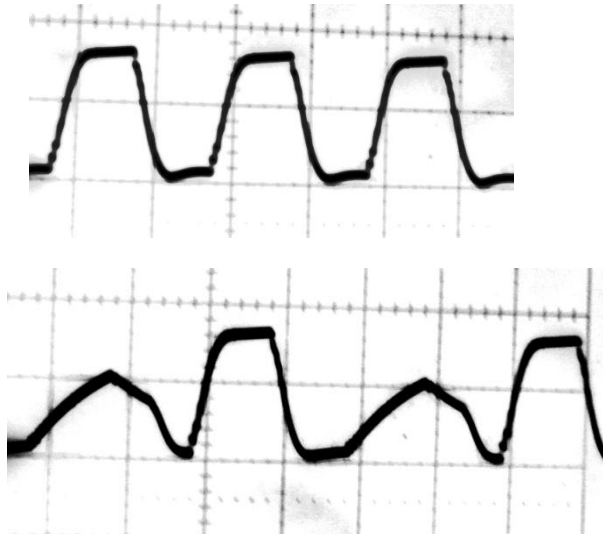
Figure 6: Solder Joint BIST – Input 1MHz Clock: Signal Across Capacitance: Normal Resistance of <1 Ohm (top) and Resistance of 100 Ohm (bottom): 2 μ s x 2.0V Grid

Referring to Figure 6, the top picture is the normal signal across a 1.0µF capacitor connected to two I/O ports selected for testing. The signal across the capacitor is caused by the SJ BIST writing '1s' and '0s.'

Still referring to Figure 6, the charged voltage on the capacitor is read from the second I/O port. The SJ BIST then writes a '1' and a '0' to the same capacitor through the second I/O port and reads the charge through the first I/O port.

A high-resistance fault in an I/O port causes the capacitor to fail to fully charge as shown in the oscilloscope view shown at the bottom of Figure 6 and Figure 7. Because of the increase in the network resistance, the charged voltage across the capacitor is less than 1.0V instead of 3.3V at the time of the read. This is logical '0' instead of a logical '1' – which is a fault. The SJ BIST detects it.

We have verified the SJ BIST works correctly for the following conditions: (1) fault during the write of a '1' to I/O port 1 and (2) fault during the write of a '1' to I/O port 2. We verified the SJ BIST works correctly with no false alarms at 100kHz, 1MHz, 10MHz and 20MHz. The test result for

1MHz is shown in Figure 6; Figure 7 shows the test result at 20MHz.

Referring back to Figure 6, the signal sequence is write-read ‘10’ (test I/O port 1), write-read ‘10’ (test I/O port 2), and continue to repeat the sequence. Parallel logic checks to see if the capacitor is written to correctly. This sequence takes two clocks to complete, which means the following: (1) a fault must have a minimum duration of two clock periods for “guaranteed” detection; (2) a fault with a duration of one-half of a clock period is detectable when it occurs at the start of either the write-read ‘1’ or the write-read ‘0’ sequence for that pin. For an FPGA with a 20MHz CLK, the guaranteed detection duration is 100ns.

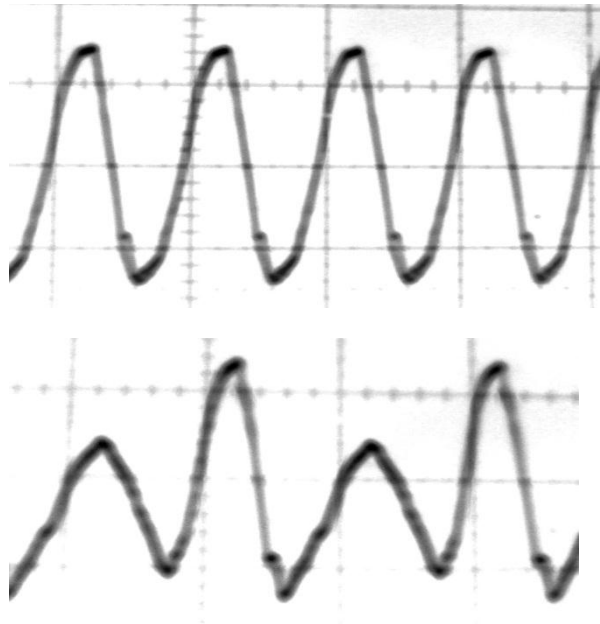
Figure 7: Solder-Joint BIST – Input 10MHz Clock: Signal Across Capacitance: Normal Resistance of <1 Ohm (top) and Resistance of 100 Ohm (bottom): 2 μ s x 2.0V Grid
