ER0023
Errata
SmartFusion Devices

This errata sheet contains updated information about any known SmartFusion[®] device family specific issues and provides available fixes and solutions.

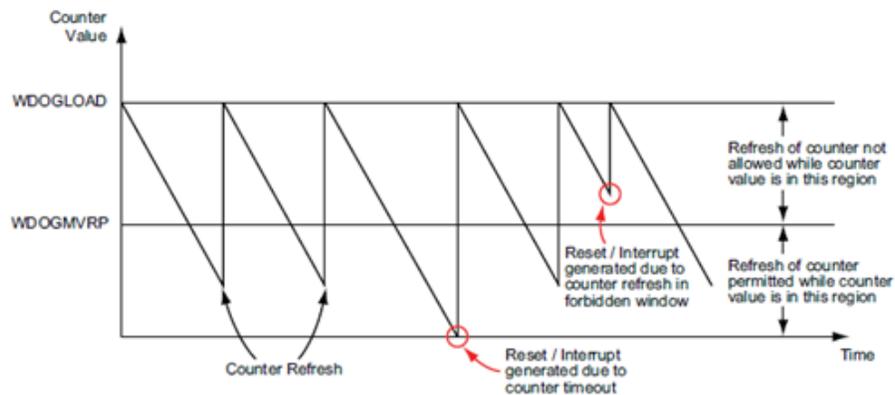
Figure 3 • Watchdog Timer Windowing Example

When the counter value falls below the level programmed in WDOGMRP, the Watchdogrefresh is permitted. The REFRESHSTATUS status bit in the WDOGSTATUS register is set when in the permitted window.

Update to Libero software v9.0 SP1 or later release along with MSS version 2.2.101.

The workaround when using an MSS version prior to version 2.2.101 is to avoid using the forbidden window by setting the maximum value to 0xFFFFFFFF, which is also the reset value.

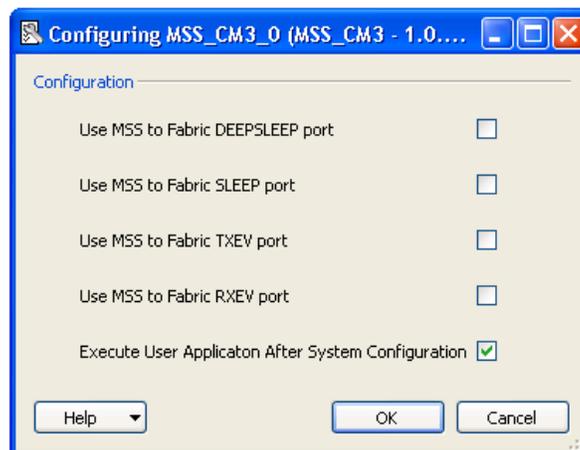
Figure 5 • System Behavior Option after System Configuration

A new option, **Execute User Application After System Configuration**, has been added into the Cortex-M3 configurator as per the following figure, that gives the user the flexibility of deciding the behavior after the system configuration. The option is ON by default, which indicates that your application is executed after system configuration. If you do not have any application to run, the check box options should be cleared.
