HALT Evaluation of SJ BIST Technology for Electronic Prognostics

Abstract—This paper presents the design, test, and results of a highly accelerated life test (HALT) evaluation of a soft-core called Solder Joint Built-in Self-Test™ (SJ BIST™), a method for detecting faults caused by solder-joint fractures in monitored input/output (I/O) pins of field programmable gate array (FPGA) devices, especially those in ball grid array (BGA) type of packages. Modern electronics utilize large FPGAs packages attached to electronic boards by means of solder joints, such as solder balls, between the package and the board. Thermo-mechanical stresses – primarily heat and vibration – cause fatigue damage and eventual fracture failure of one or more balls, which causes intermittent operational faults leading to catastrophic failures in critical systems. Such intermittent faults are difficult to reproduce on a test bench and many field returns of electronic modules with intermittently failing solder balls are diagnosed with code "no trouble found/could not reproduce." The SJ BIST soft-core offers a solution because it detects faults in monitored pins caused by fractured solder joints of programmed FPG

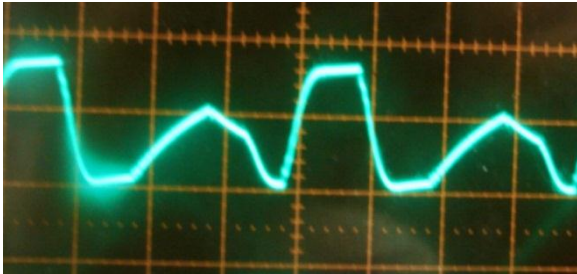
Figure 7. High solder-joint resistance in an I/O port causes faults.

For each selected group of 2 pins, SJ BIST writes a ‘10’ bit pattern through a first I/O port of a two-pin group to charge and discharge a capacitor attached to that group. The second I/O port of the group is used to read the ‘1’ bit immediately after it is written. When the resistance of the first I/O port becomes too large, the charge on the capacitor will be insufficient to be read as a ‘1’ bit (see Fig. 7). In the next clock cycle, the ‘10’ is written using the second I/O port and the first I/O port is used to read the ‘1’ bit.

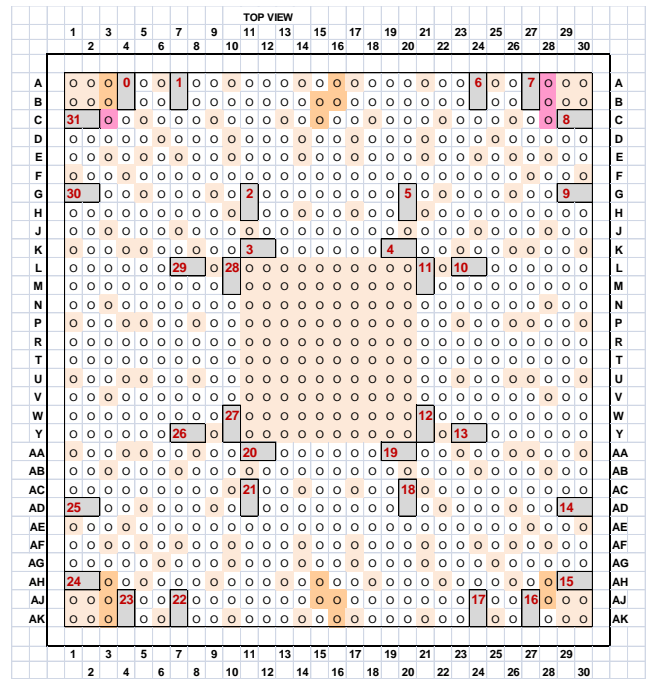
Figure 8. Monitored groups of two pins each.

The two-pin soft-core for SJ BIST was used to create a firmware program that monitored 32 groups of two pins; 64 pins total. The monitored groups are shown in Fig. 8, and the group and pin numbers are shown in Table II.
