ER0207

Errata

PolarFire FPGAs: Engineering Samples (ES) Devices

November 2018

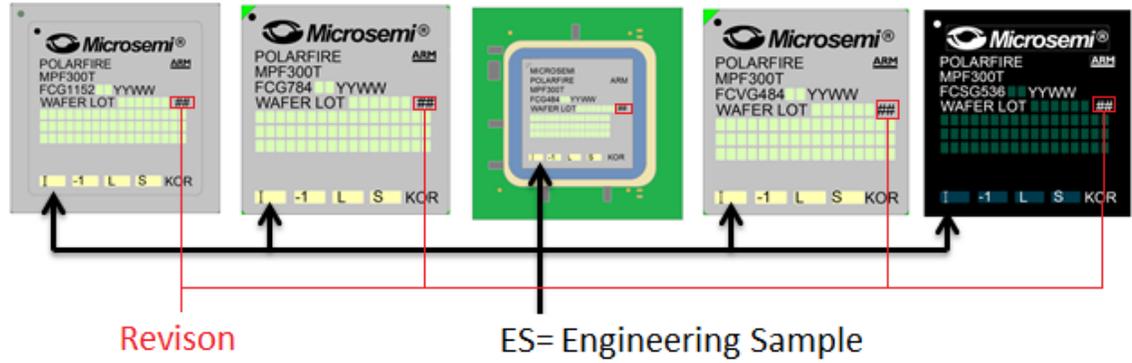
Figure 1 • ES Identification Markings

PolarFire FPGA engineering samples can be identified by the temperature grade field in the lower left-hand corner. As the following illustration shows, an ES annotation will appear in the temperature grade field indicating device is engineering sample and revision marking is shown along right side of code mark.
