ER0207
Errata
PolarFire FPGA - ES Devices

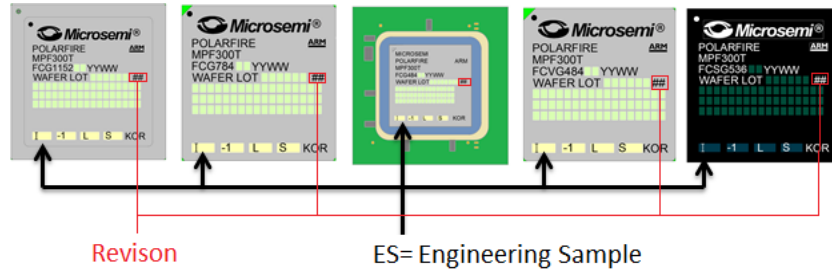
Figure 1 • ES Identification Markings

PolarFire FPGA engineering sample can be identified from the Temperature Grade field in the lower left hand corner as shown in the following figure.

Figure 1	ES Identification Markings	10
----------	----------------------------------	----
