PCN Number: 0625

Subject: Routed Clock Timing on Axcelerator[®] and RTAX-S

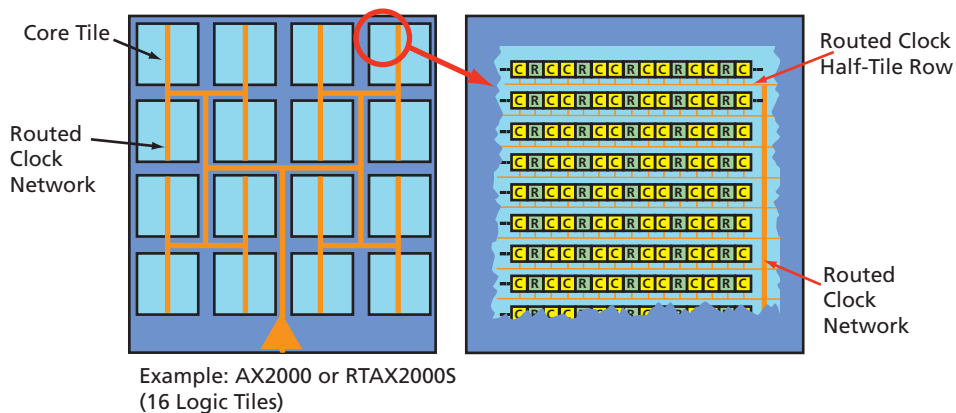
Figure 1 • Figure 1: AX Routed Clock Half-Tile Row (HTR) Architecture

In the AX and RTAX-S architecture, each device is comprised of core tiles. For example, an AX2000 or RTAX2000S device includes 16 core tiles in a 4x4 array. Each core tile is served by four routed clock segments, which run along the middle of the core tile. Logic modules, I/O cells, and SRAM cells are served by ribs branching off the central routed clock segments. Each of these ribs is called a routed clock half-tile row (HTR). See Figure 1 for more information.

The maximum number of loads that any HTR can serve is 44. The loads are separated into the following groups:

- 12 R-cells
- 24 C-cells
- 2 SRAM cell loads
- 6 I/O registers (2 I/O cells with 3 registers each)
