# INTERMITTENCY DETECTION AND MITIGATION IN BALL GRID ARRAY (BGA) PACKAGES

**Abstract** – An update on a method (SJ BIST™) to detect intermittencies in Ball Grid Array (BGA) packages is presented, and another method (SJ Monitor™) is introduced. SJ BIST™ is primarily firmware embedded in the FPGA application; SJ Monitor™ is hardware on an IC chip.

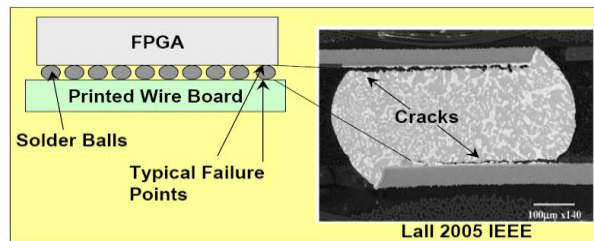
Solder-joint damage under thermo-mechanical and shock stresses is cumulative and is manifested as plastic work leading to voids and cracks, as seen in Figure 1; cracks propagate to become fractures [2-5] which cause FPGA operational faults. Thermo-mechanical stresses

**Figure 1: Crack Propagation at the Top and Bottom of a Solder Ball, 15 mm BGA [3].**

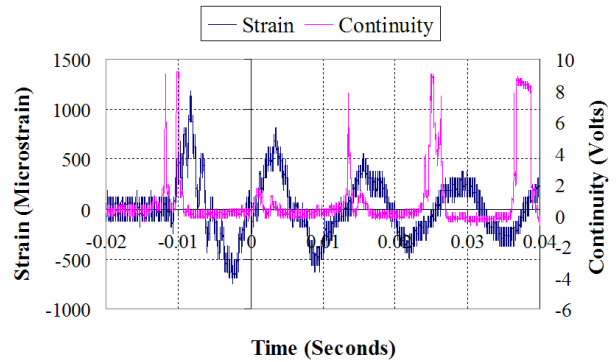
These intermittent faults increase in frequency as evidenced by a practice of logging BGA package failures only after multiple events of high-resistance: an initial event followed by some number (for example, 2 to 10) of additional events within a specified period of time, such as ten percent of the number of cycles of the initial event [9-11]. Even then, an intermittent fault in a solder-joint network might not result in an operational fault. For example, the fault might be in a ground or power connection; or it might occur during a period when the network is not being written; or it might be too short in duration to cause a signal error. Figure 2 shows shock-actuated intermittent faults in a package interconnect: the duration of the fault during the 5<sup>th</sup> cycle is over 3 milliseconds.

**Figure 2: Shock-actuated Failure: Transient Strain (Blue) and Intermittent Opens (Mauve).**

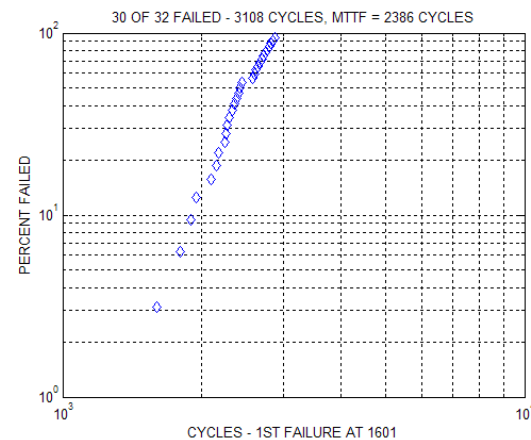
Figure 3 represents HALT test results performed on XILINX FG1156 Daisy Chain packages in which 30 out of 32 tested packages failed in a test period consisting of 3108 HALT cycles. Each temperature cycle of the HALT was a transition from  $-55^{\circ}\text{C}$  to  $125^{\circ}\text{C}$  in 30 minutes: 3-minute ramps and 12-minute dwells. What is not immediately apparent is that each of the logged FPGA failures (diamond symbols) represents at least 30 events of high resistance: a FAIL was defined as being at least 2 OPENS (net resistance of  $500\ \Omega$  or higher) within one temperature cycle, log the package as failed after 15 FAILS [10]. A single OPEN in any temperature cycle was not counted as a FAIL event.

**Figure 3: Representation of XILINX FPGA HALT Test Results [9].**

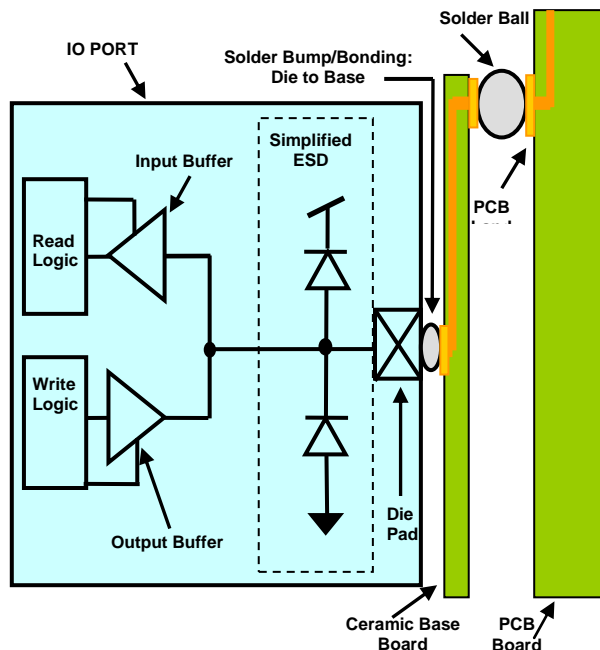
These sensor methods are the first known for detecting faults in solder-joint networks of I/O ports of operational, fully-programmed FPGAs. Furthermore, FPGAs are not amenable to the measurement techniques typically used in manufacturing reliability tests such as Highly Accelerated Life Tests (HALTs) [5]. This is because, for example, a 4-point probe measurement requires devices to be powered-off; and because FPGA I/O ports are digital, rather than analog, circuits (see Figure 4).

Figure 4: FPGA Diagram, I/O Buffer [17,18].

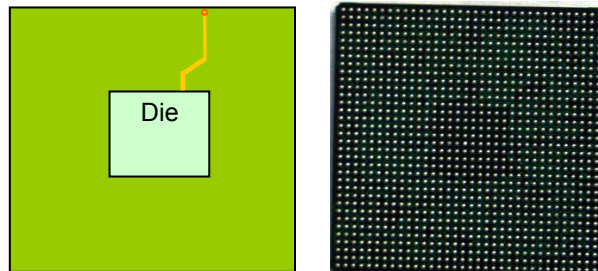
Modern BGA FPGAs have more than a thousand pins and very small pitch and ball sizes, for example, Figure 5 shows the bottom of a XILINX FG1156 with a footprint of  $35 \times 35 \text{ mm}^2$ , and an array of  $34 \times 34$  solder balls.

Figure 5: XILINX FG1156: Size is  $35 \times 35 \text{ mm}^2$ ; Pitch: 1.0 mm. Ball: 0.6 mm [17,18].

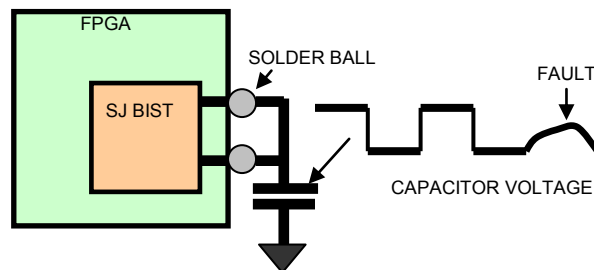
SJ BIST requires the attachment of a small capacitor to an unused I/O port as near as possible to a corner of the package. Figure 6 is a block diagram of an FPGA containing SJ BIST with a capacitor connected to two I/O pins.

Figure 6: SJ BIST Block Diagram

Referring to Figure 6, SJ BIST writes a logical '1' to charge the capacitor and then reads the voltage across the charged capacitor. If the solder-joint network of the I/O port of the FPGA is undamaged, the write causes the capacitor to be fully charged and a logical '1' is read by SJ BIST. When the solder-joint network is damaged, the effective resistance of the SJ network increases, the charging time constant increases, the write fails to sufficiently charge the capacitor, and a logical '0' instead of a logical '1' is read: a fault occurs, is detected by SJ BIST and is reported.

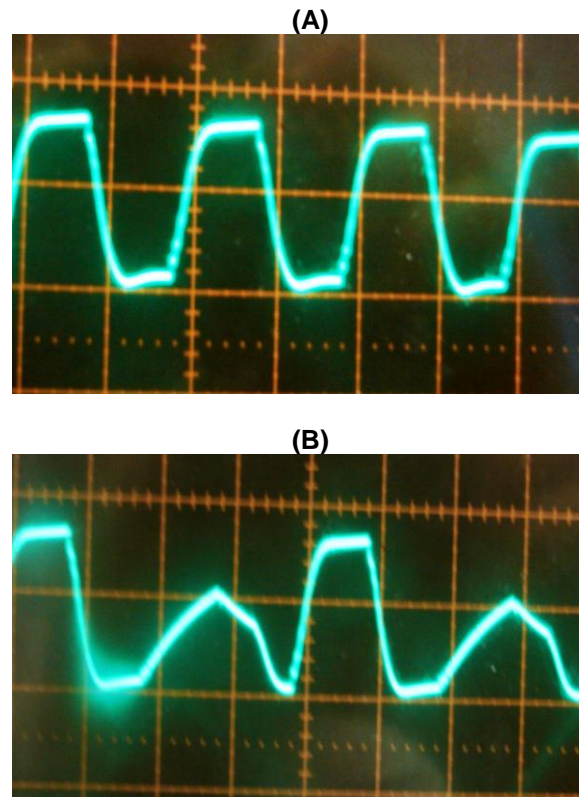
Referring to Figure 7, two sets of voltages on a 1.0  $\mu$ F capacitor connected to a group of two I/O ports are shown. Figure 7A shows the capacitor voltage when one of the two ports connected to the capacitor has a 1  $\Omega$  resistor connected in series with the solder joint: the resistance is not high enough cause a write fault to occur, and SJ BIST correctly did not report a detected fault.

Figure 7B shows the capacitor voltage when the resistance is increased to 100  $\Omega$ , a write fault occurs. SJ BIST correctly reported the fault and incremented the fault count for that I/O pin.

**Figure 7: SJ BIST: 1 MHz Capacitor Signal. Top is for a No Fault Condition; Bottom is for a Fault Condition (100  $\Omega$ ) – 0.5  $\mu$ s x 2.0V Grid.**

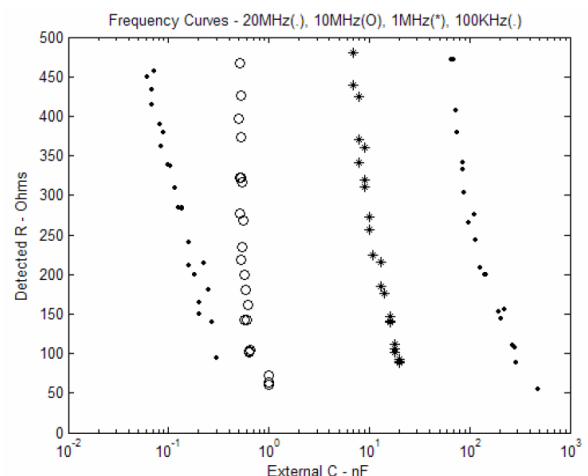
There is a relationship between the frequency of the FPGA clock, the value of the connected capacitor to each group of two I/O pins, and the detectable fault resistance. Figure 8 shows the results of tests conducted in September of 2006: For a given clock frequency, there is a capacitor value that will cause SJ BIST to always detect a fault resistance at least as low as 100  $\Omega$ .

**Figure 8: Clock Frequency, External Capacitor Value and Detectable Fault Resistance – Sep. 2006.**

The primary objectives are the following: (1) perform final sensitivity, resolution and clock frequency measurements to update Figure 8; (2) collect, evaluate and publish statistical data related to test I/O port location, first failure and probability of failure distribution.

Figure 17 shows a test result using a known fault of  $300\ \Omega$ , a 25 MHz clock and a 47 pF capacitor. The result is actually better than that predicted by Figure 8: for a  $300\ \Omega$  fault, a 20 MHz clock and a 100 pF capacitor.

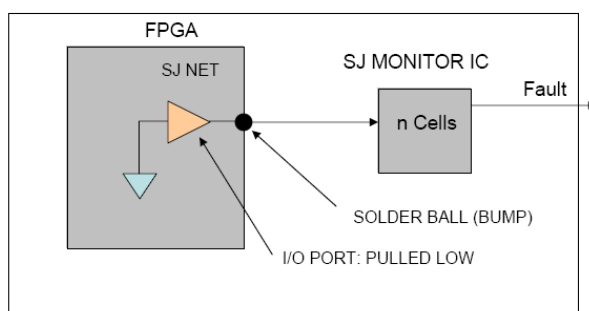
SJ Monitor is designed and is being developed as an Integrated Circuit (IC) chip, which must be mounted next to and connected to the FPGA on the board. SJ Monitor is a low-power, continuous monitoring sensor: at 1.2 V to 2.5 V, it uses less than 5.0 mW to monitor 8 I/O pins. SJ BIST has a power requirement of over 100 mW to test 8 I/O pins. A block diagram representation of SJ Monitor is shown in Figure 9.

**Figure 9: SJ Monitor Block Diagram**

Although an active I/O port is shown in Figure 9, an active port is not a requirement: the only requirement is the port must be at logical zero level.

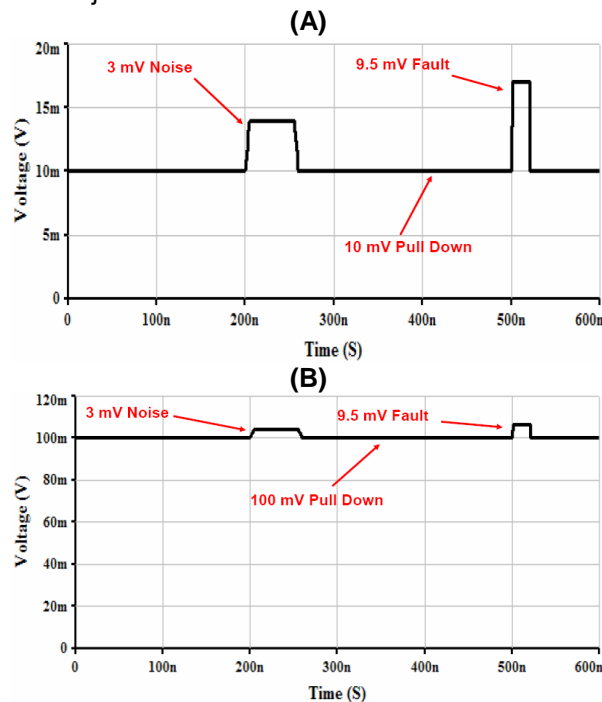
Referring to Figure 10, (A) shows an I/O pin with a pull-down voltage level of 10 mV and (B) shows an I/O pin with a pull-down voltage level of 100 mV. Superimposed on each of the pull-down voltage levels are 3.0 mV noise pulses and 9.5 mV fault perturbations. The fault perturbations are caused by injecting a 100  $\Omega$  fault into the solder-joint network.

**Figure 10: FPGA I/O Pin Voltages: (A) Pull-down is 10 mV and (B) Pull-down is 100 mV; Noise is 3.0 mV, Fault Perturbation is 19.5 mV.**

SJ Monitor is insensitive to a specific value of pull-down voltage: Both of the input conditions seen in Figure 10 result in the output shown in Figure 11. SJ Monitor uses signal conditioning to ignore the pull-down voltage level, to suppress noise and to amplify the fault perturbation to produce a digital fault signal.

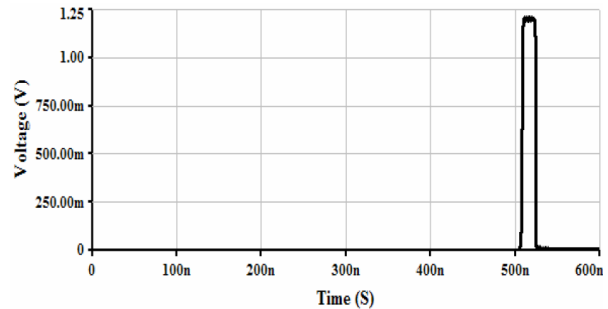
**Figure 11: SJ Monitor Fault Signal Response to Figure 10 A and B.**

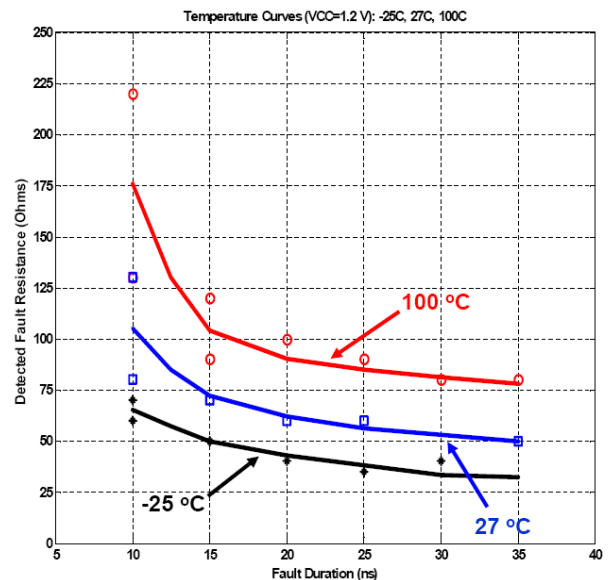
The value of the minimum detectable fault resistance is primarily dependent on the duration of the fault and the operating temperature as shown in Figure 12. The results indicate that SJ Monitor is able to detect a fault resistance at least as low as 100  $\Omega$  when the fault duration is at least as long as 20 ns.

**Figure 12: Temperature, Fault Resistance and Fault Duration Curves.**

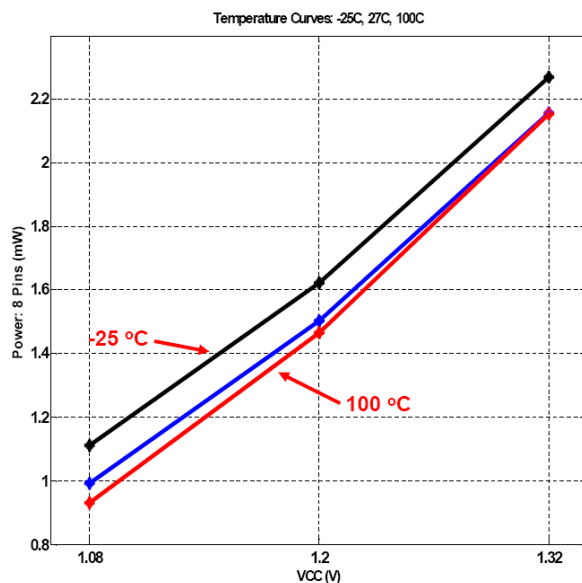
Test simulations showed SJ Monitor has a power requirement of between 0.9 mW and 2.4 mW to monitor 8 I/O pins, depending on temperature and voltage. This low power requirement makes SJ Monitor suitable for continuous monitoring and for short test applications.

**Figure 13: Power Used vs Temperature and Supply Voltage (VCC).**

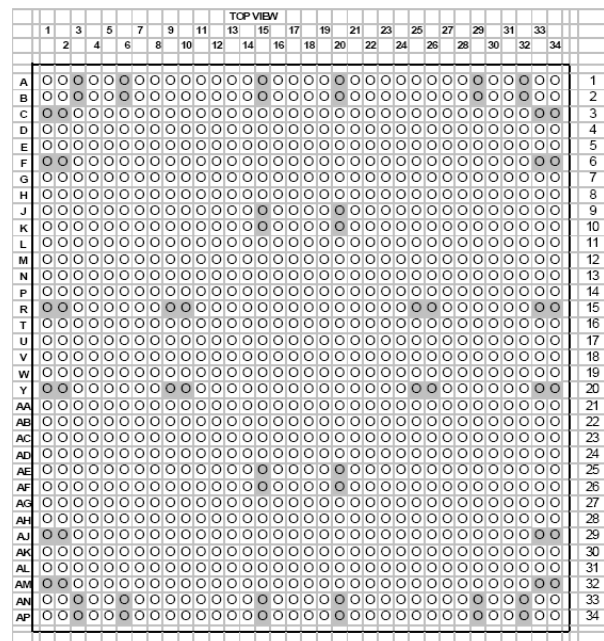
Figure 14 is a footprint for a XILINX FG1156 FPGA showing the I/O pins (shaded) we selected for testing by SJ BIST. Sixty-four I/O pins were selected, so there are 32 groups of SJ BIST cores in our test program.

**Figure 14: FG1156 Footprint Showing Selected SJ BIST I/O Pins: 32 Groups, 64 Pins.**

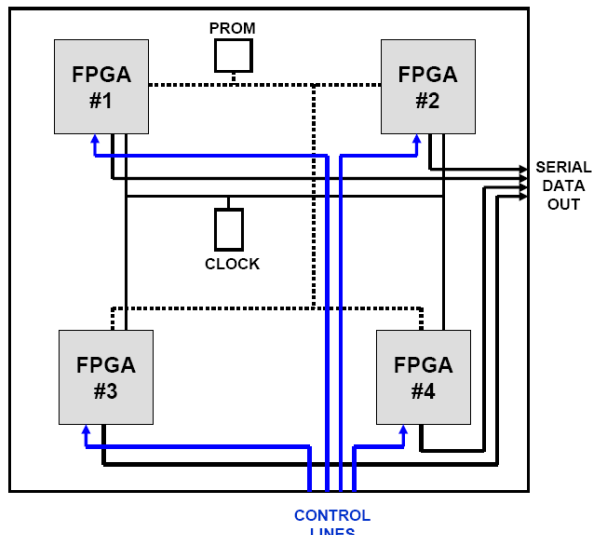
Figure 15 is a block diagram of the HALT test board we designed. We load the SJ BIST test program into a PROM, which then loads the program into each FPGA when the board is powered on. Each FPGA generates 640 bits of data (64 x (2 faults signals + 8 bits of count)); each board generates 2560 bits of data, and we have 4 boards in the HALT oven = 10,240 bits of data for each sample period. We wrote a LabVIEW® program to control the collection of data, and we wrote a MATLAB® program to process the data.

Figure 15: HALT Test Board Block Diagram.

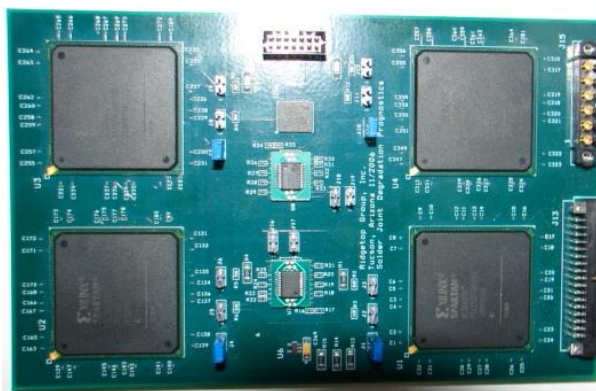
Figure 16 shows a manufactured, populated and soldered HALT test board. There are three connectors: (1) XILINX programmer connection, (2) power input and (3) experiment control connections.

Figure 16: HALT Experiment Board with Four XILINX FG1156 FPGAs.

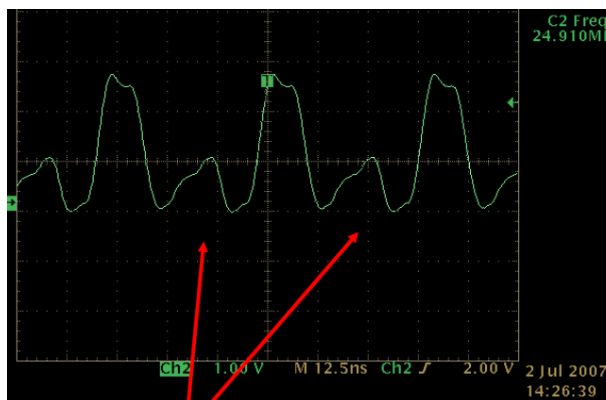
300 Ohm Fault  
Figure 17: 25 MHz CLK, 47 pF,  $300\ \Omega$  Test.

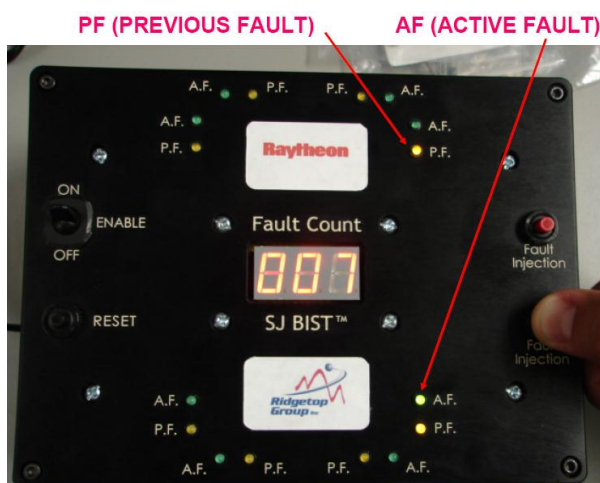
**Error! Reference source not found.** is a picture of one of the SJ BIST demonstration boxes being tested for delivery to Raytheon Missile Systems. The front panel shows a fault count of 7, a previously detected fault in an upper-right pin, and both an active (the fault inject button is depressed) and a previously detected fault in a lower-right pin. The purpose of the box is to allow for portable demonstrations, and to allow non-Ridgetop personnel to independently demonstrate and evaluate SJ BIST.

Figure 18: SJ BIST Demonstration Box.

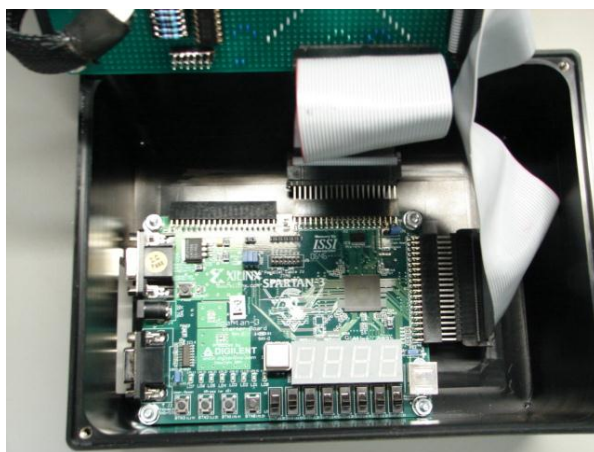
Figure 19 is a picture of the XILINX SPARTAN®-3 board inside of the SJ demonstration box. We programmed the FPGA to monitor 8 I/O pins.

Figure 19: SJ BIST Demonstration Box, XILINX Spartan 3 Board.

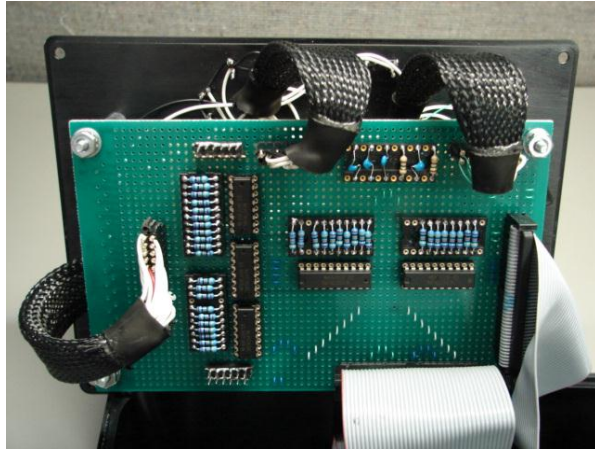
Figure 20 is a picture of the display control board for the SJ BIST demonstration board. The board provides the interface and control between the box front panel and the FPGA. Not shown is a small board upon which the 7-segment LED is mounted. Future versions of the SJ BIST demonstration box will use a printed circuit board instead of a bread board.

**Figure 20: SJ BIST Demonstration Box, Display Board.**
